Monroe County
Land Conservation Department

Town of Angelo Stream Crossing Survey

7/6/2023

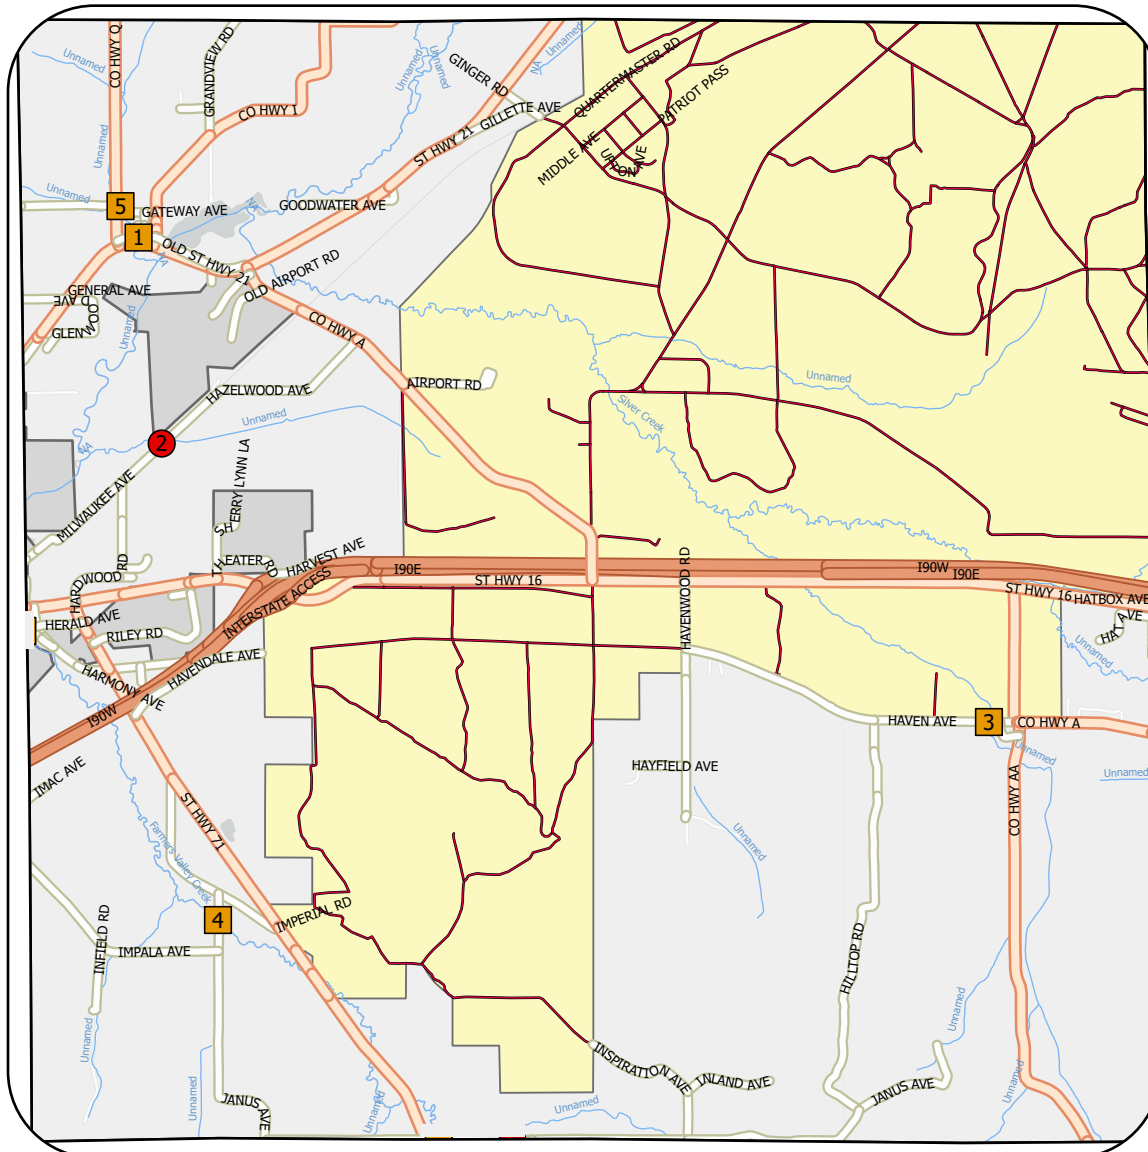
Replacement Priority Ranking at Road Stream Crossings

Rank	Crossing Name	Score	Recommended Action
1	Old State Highway 21	22	Closely Monitor
2	Hazelwood Avenue	20	Annual Assessment
3	Haven Ave and CTH-A	18	Annual Assessment
4	Janus Avenue N of intersection with Impala Avenue	16	Annual Assessment
5	Gateway Avenue	8	None

Crossings are ranked by order of need for replacement based on a weighted combination of flood risk, structure condition and aquatic passability. Flood risk is weighted the heaviest and aquatic passability the lightest.

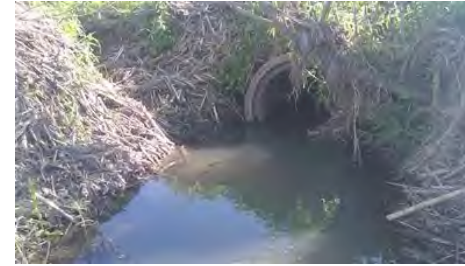
Example of a high flood risk stream crossing (score of 35) at the 1st crossing from Co Hwy J and a trib to the Little La Crosse.

Crossings are at increased risk of failure from flooding if the structure is undersized, not aligned with the stream, or has unprotected embankments. Minimum size recommendations are 1.2 times the bankfull width of the stream with ideal sizing of 1.2 times the bankfull width + 2ft.

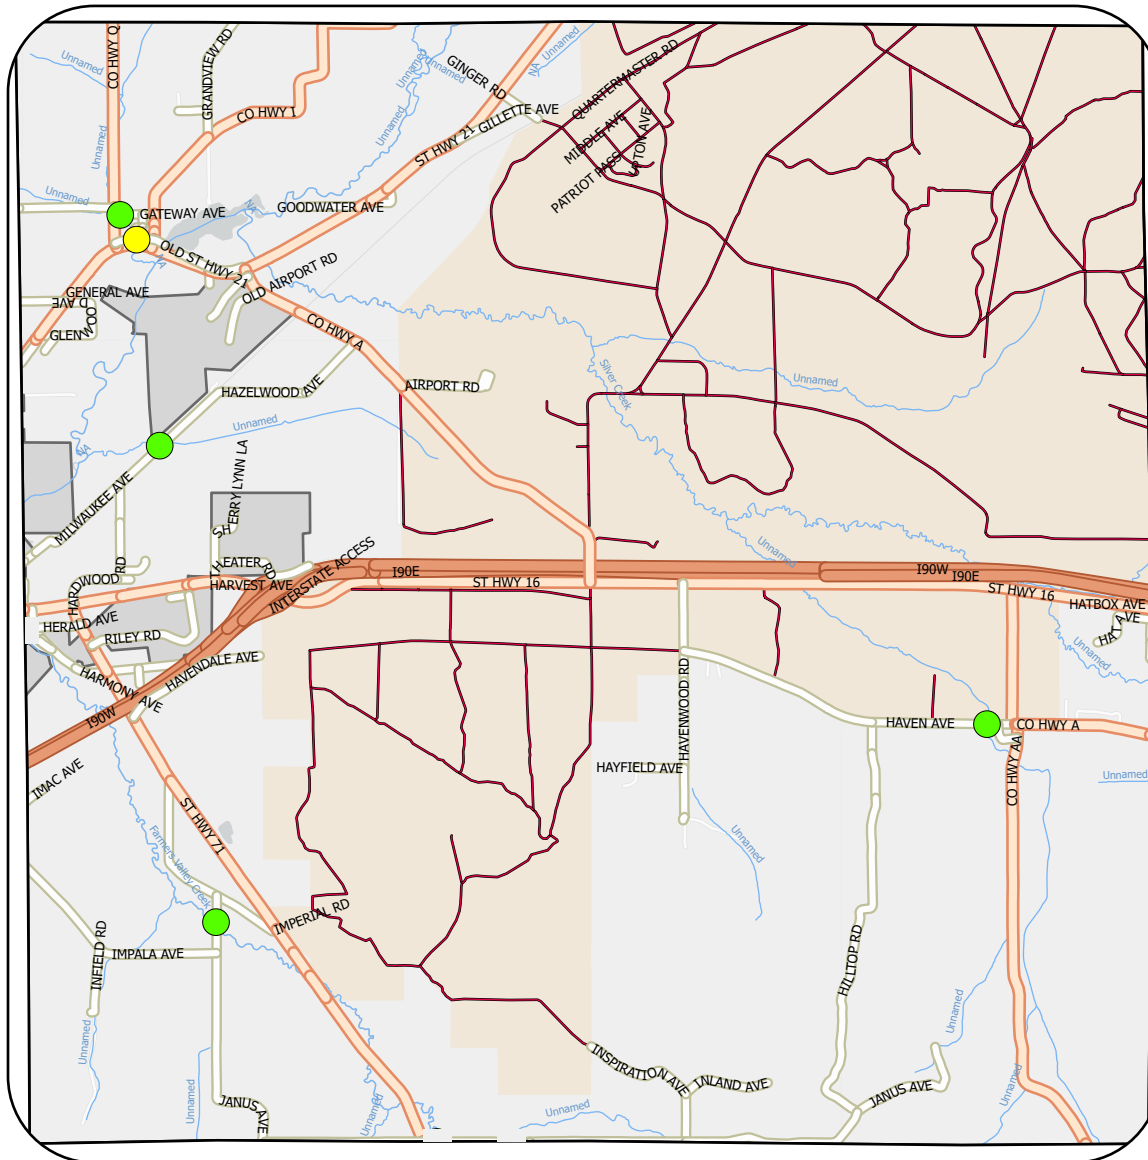
Structure Condition at Road Stream Crossings

Structure conditions are considered good if there is no evidence of corrosion, abrasion, cracking, spalling, chipping or shape changes.

Moderate deterioration is identified patches of corrosion or abrasion on less than 5% of the structure or minor cracks, spalling, chipping or shape changes.

- Moderate Deterioration
- Good Condition

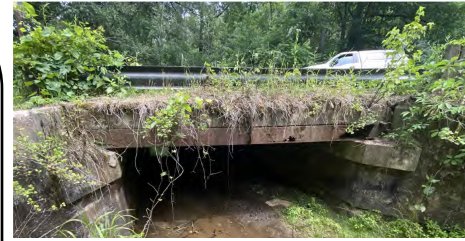
Example of major deterioration of a bridge crossing on Neptune Road.

Major deterioration is identified patches of corrosion or abrasion on greater than 5% of the structure or medium to large cracks, spalling, chipping or shape changes.

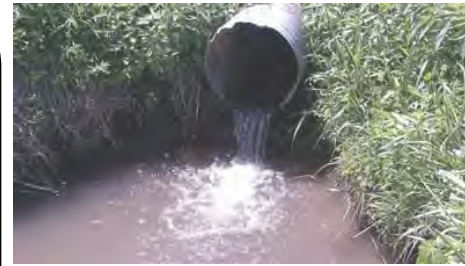
Example of an aquatic barrier due to perching at Kate Ave stream crossing of a trib to the Little La Crosse

Crossings can act as a barrier to fish movement and other aquatic organisms during normal stream flow conditions.

All road-stream crossings in Angelo are barriers to aquatic life. Barriers can prevent fish movement upstream to potential spawning beds and diminish organic energy and matter throughout the system. This can be prevented by eliminating perches and decreasing water velocity through properly designed structures. Efforts should focus on crossings lower in the water shed in order to increase connectivity to more stream miles.
